Project M4– NP010

MAPS 4 Parks Programming for Neighborhood and Community Parks Master Plan Development

JANUARY 2025

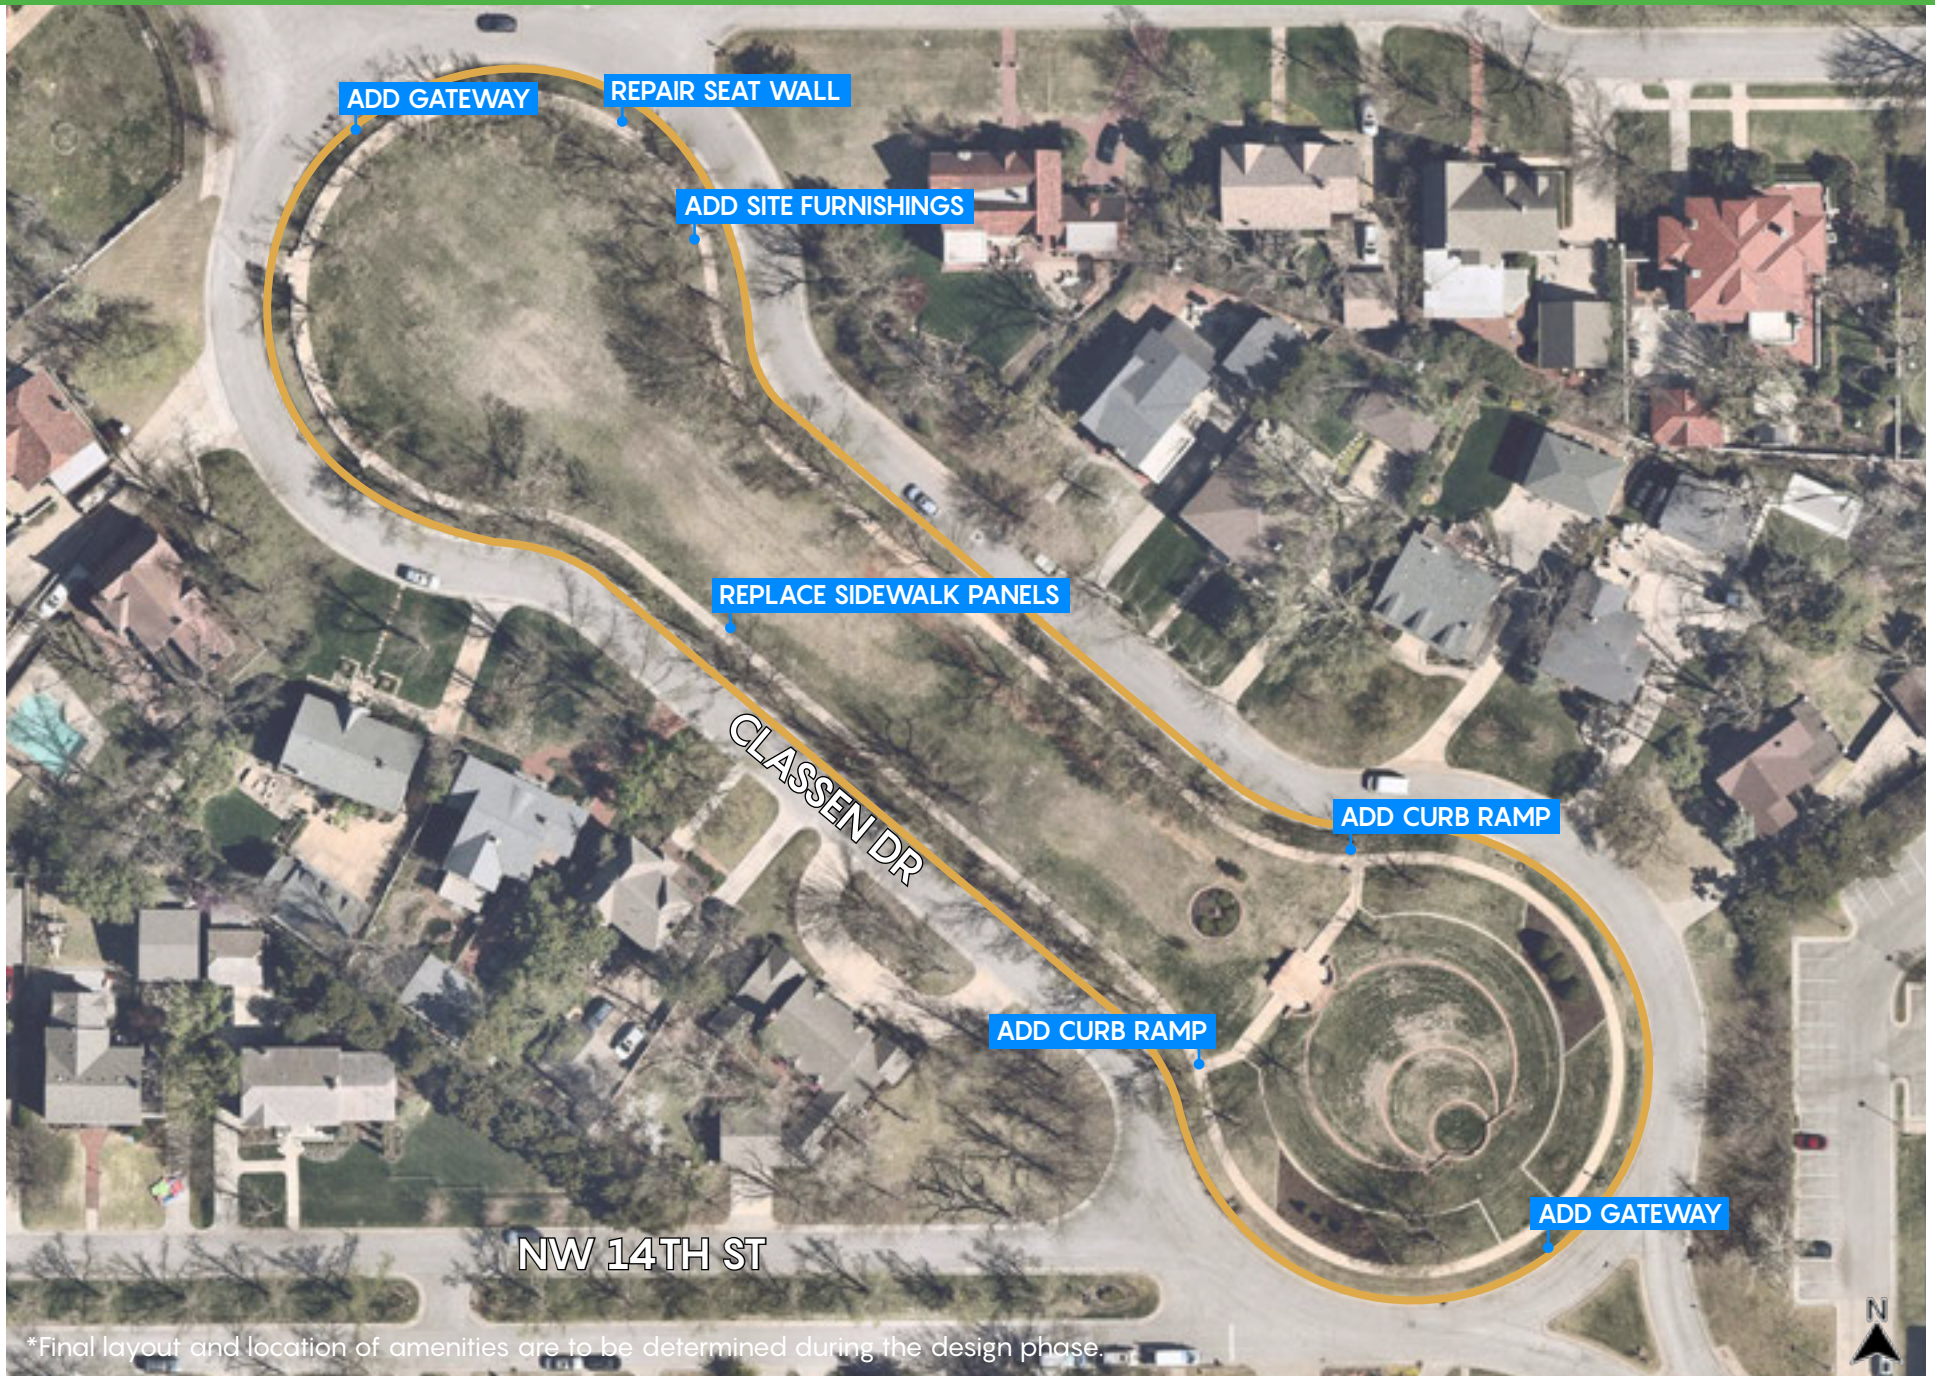
Alice Harn Park

Amenity	Qty.	Grade	Notes
Bench	2	C	Stone seating has minor cracking.
Sculpture	1	A	Statue is in good condition.
Seat Wall	N/A	C	Seat wall has minor wear on the cap and on the wall.
Sidewalk	N/A	D	Sidewalk has major cracking in some areas which causes safety concerns for users.
Trash Receptacle	1	A	Trash receptacle is in great condition.
Tree Coverage	N/A	B	
Open Space	N/A	C	
Lighting	N/A	C

1. Remove and replace sidewalk segments/panels
2. Repair seat wall
3. Add (4) benches
4. Add (2) dog waste stations
5. Add (1) trash receptacle
6. Add (2) gateways
7. Add (2) curb ramps

1. Add (4) trees to replace dead ones on SE side
2. Add decorative fountain

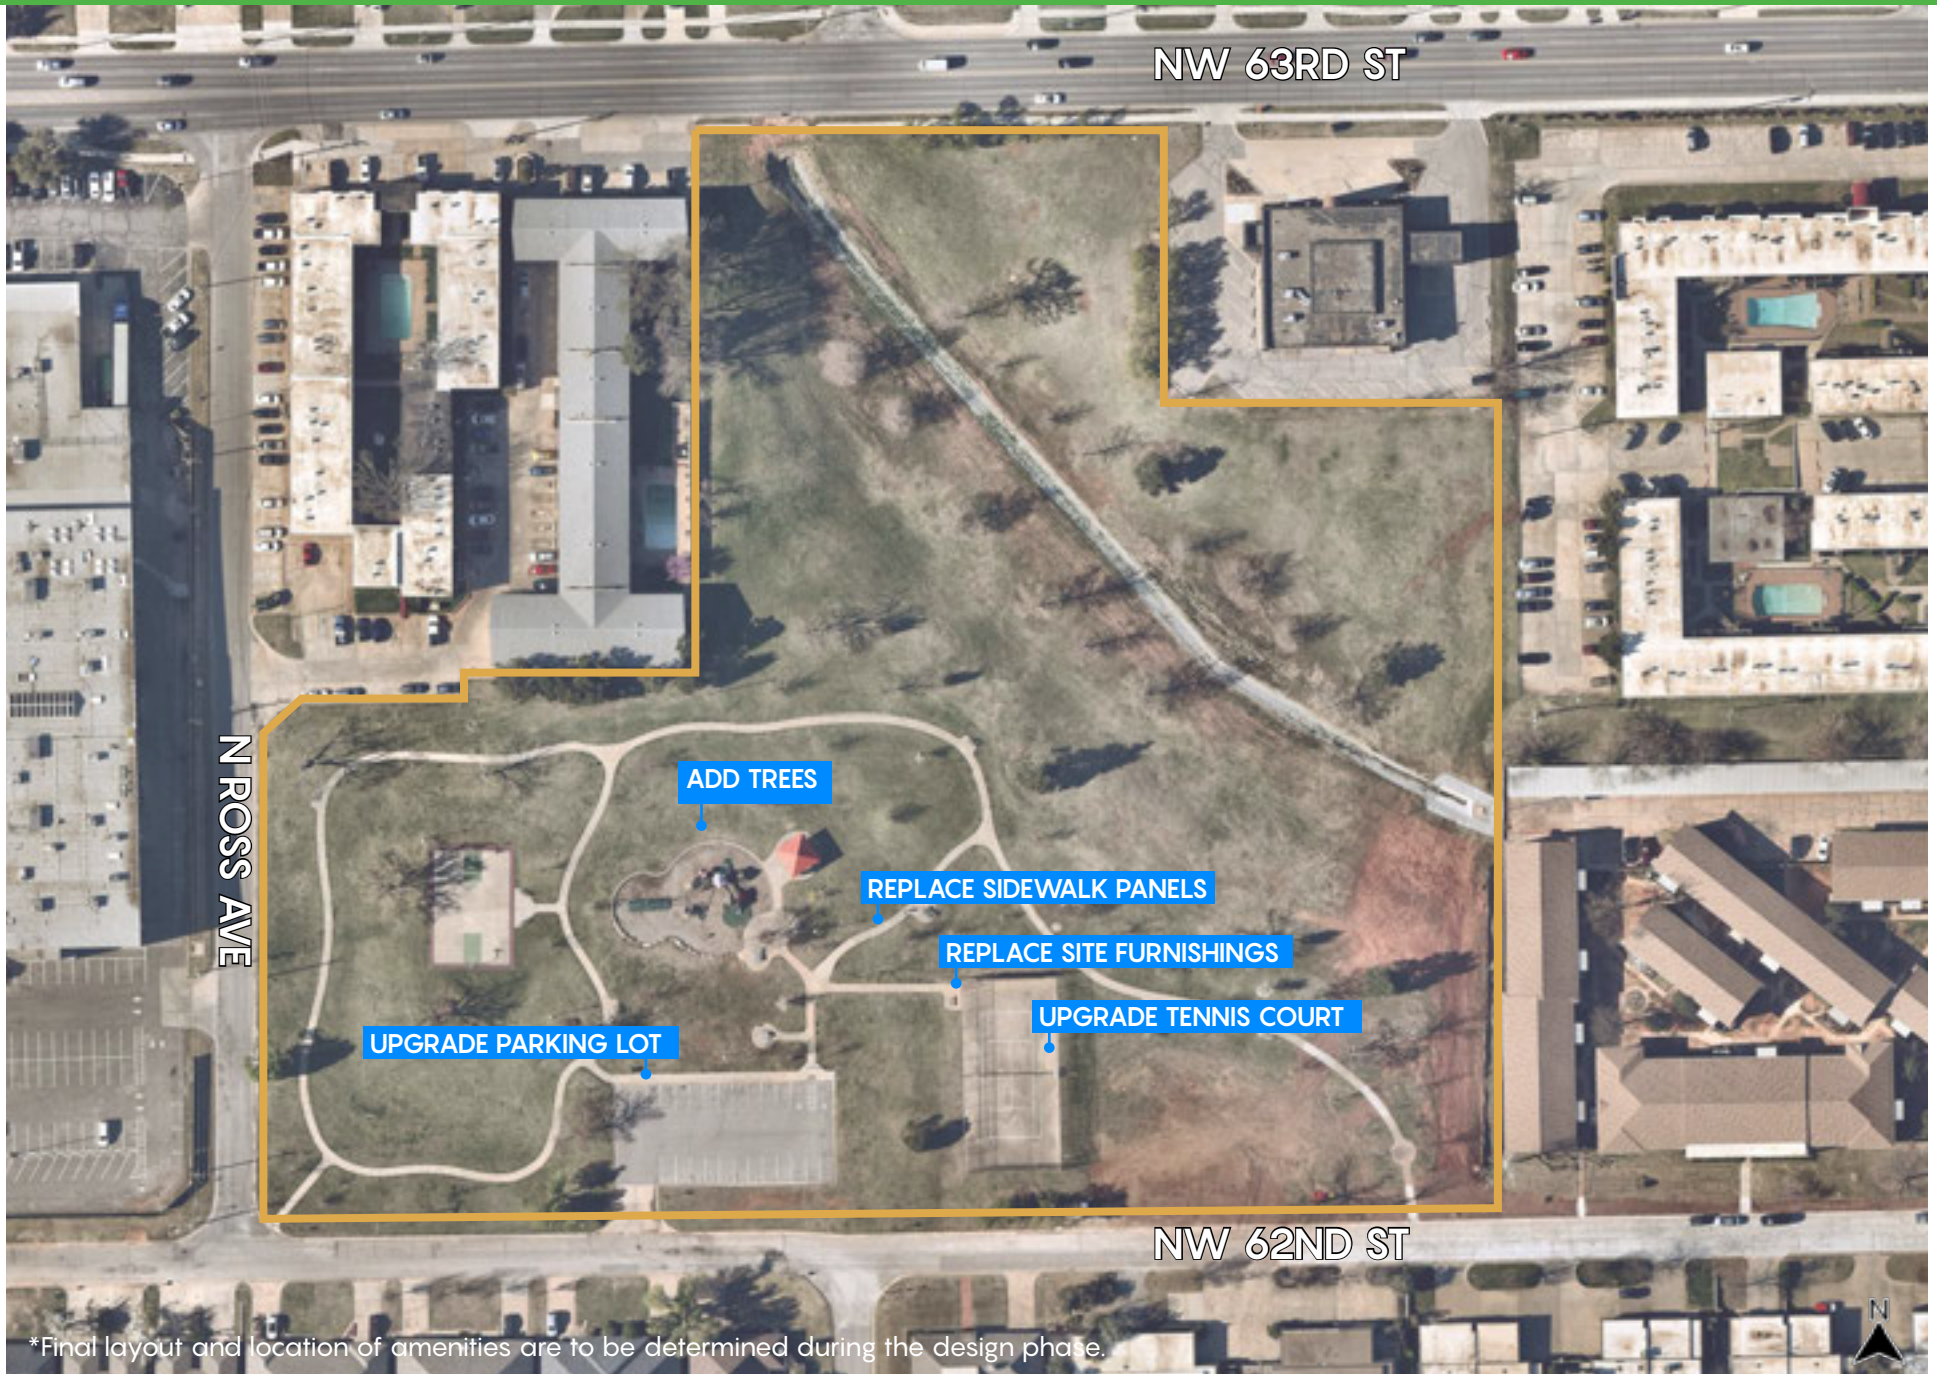
4.2 Belle Isle Park

Amenity	Qty.	Grade	Notes
Basketball Court	1	C	Goals, striping, and paint are aging and faded. Concrete is in good condition with little to no cracking.
Bench	9	D	Benches are all aging with coating wearing off and minor rusting or wood that is deteriorating.
Dog Waste Station	4	C	Dog waste stations are in decent condition; some are worn and missing elements.
Parking Lot	1	D	Parking lot has major cracking throughout.
Picnic Table	6	F	Tables are all deteriorating or rusting with coating wearing off.
Playground	1	C	Playground has minor rusting and equipment is sun-faded.
Sidewalk	N/A	D	Segments of sidewalk are deteriorating and have major cracking.
Signage (Park Entry)	1	C	Paint on park sign is in good condition; minor deterioration at base of posts.
Swing Set	1	C	Swing set has minor tears in surfacing. General repair/maintenance needed to structure.
Tennis Court	1	D	Concrete has cracking throughout with aging elements such as the singles wall and fencing.

1. Remove and replace (6) picnic tables
2. Remove and replace (9) benches
3. Repair parking lot
4. Remove and replace sidewalk segments/panels
5. Resurface and restripe tennis court to include pickleball
6. Remove and replace tennis court fence, net, and (1) singles wall
7. Add shade over benches near court areas
8. Remove and replace (2) dog waste stations
9. Add (10) trees

1. Remove and replace playground with shaded playground
2. Add sidewalk connection from parking lot to NW 62ns St. & N. Miller Ave. intersection

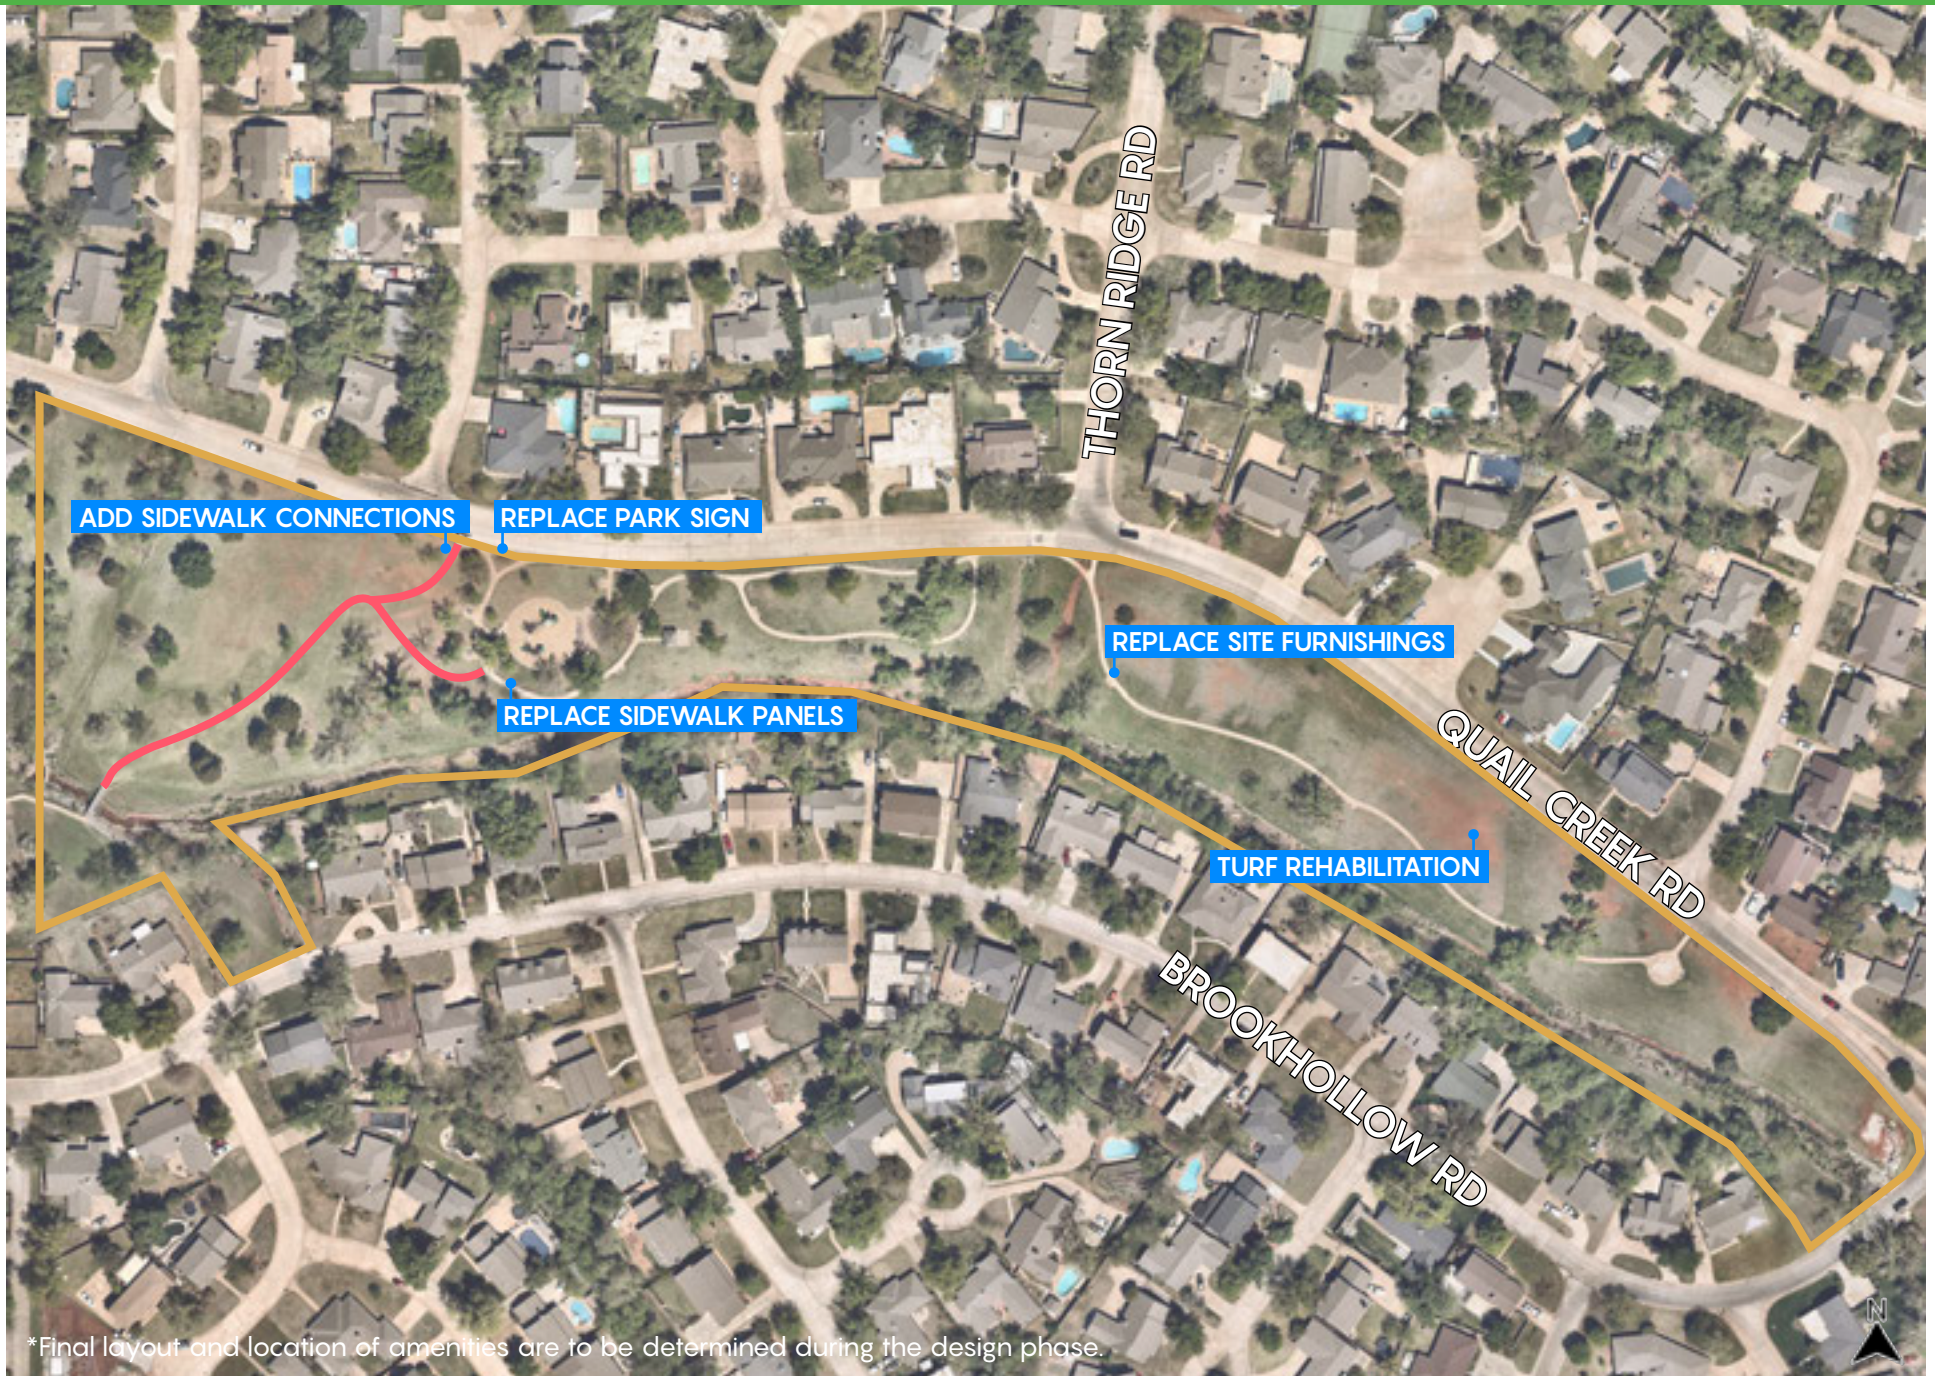
Berta Faye Rex Quail Creek Park

Amenity	Qty.	Grade	Notes
Bench	6	D	Benches are in poor condition. Wood is deteriorating or metal is rusting. Memorial bench is in decent condition.
Bike Rack/ Loop	1	C	Bike racks are in decent condition, needs general repair.
Dog Waste Stations	2	C	Waste stations are in decent condition, needs general repair.
Picnic Tables	5	F	Wood picnic tables are warping and in poor condition. Tables in open space are in poor condition with no concrete pads, rusting, and paint coating wearing off.
Playground	1	B	Playground has minor fading but is in good condition overall.
Shade Structure	1	A	Great condition.
Sidewalk	N/A	C	Main loop of sidewalk has minor cracking. Sidewalk near playground is aging with more significant cracking.
Signage (Park Entry)	1	D	Wood is deteriorating on sign and is aging.
Swing Set	1	B	Swing set is in decent condition. Surfacing needs general repair.
Trash Receptacles	5	D	In decent condition, but are aging and rusting.

1. Remove and replace (5) picnic tables
2. Remove and replace (6) benches
3. Remove and replace (1) park sign
4. Remove and replace sidewalk segments/panels
5. Add sidewalk connections (includes maintenance crossing)
6. Repair (1) dog waste station
7. Turf rehabilitation

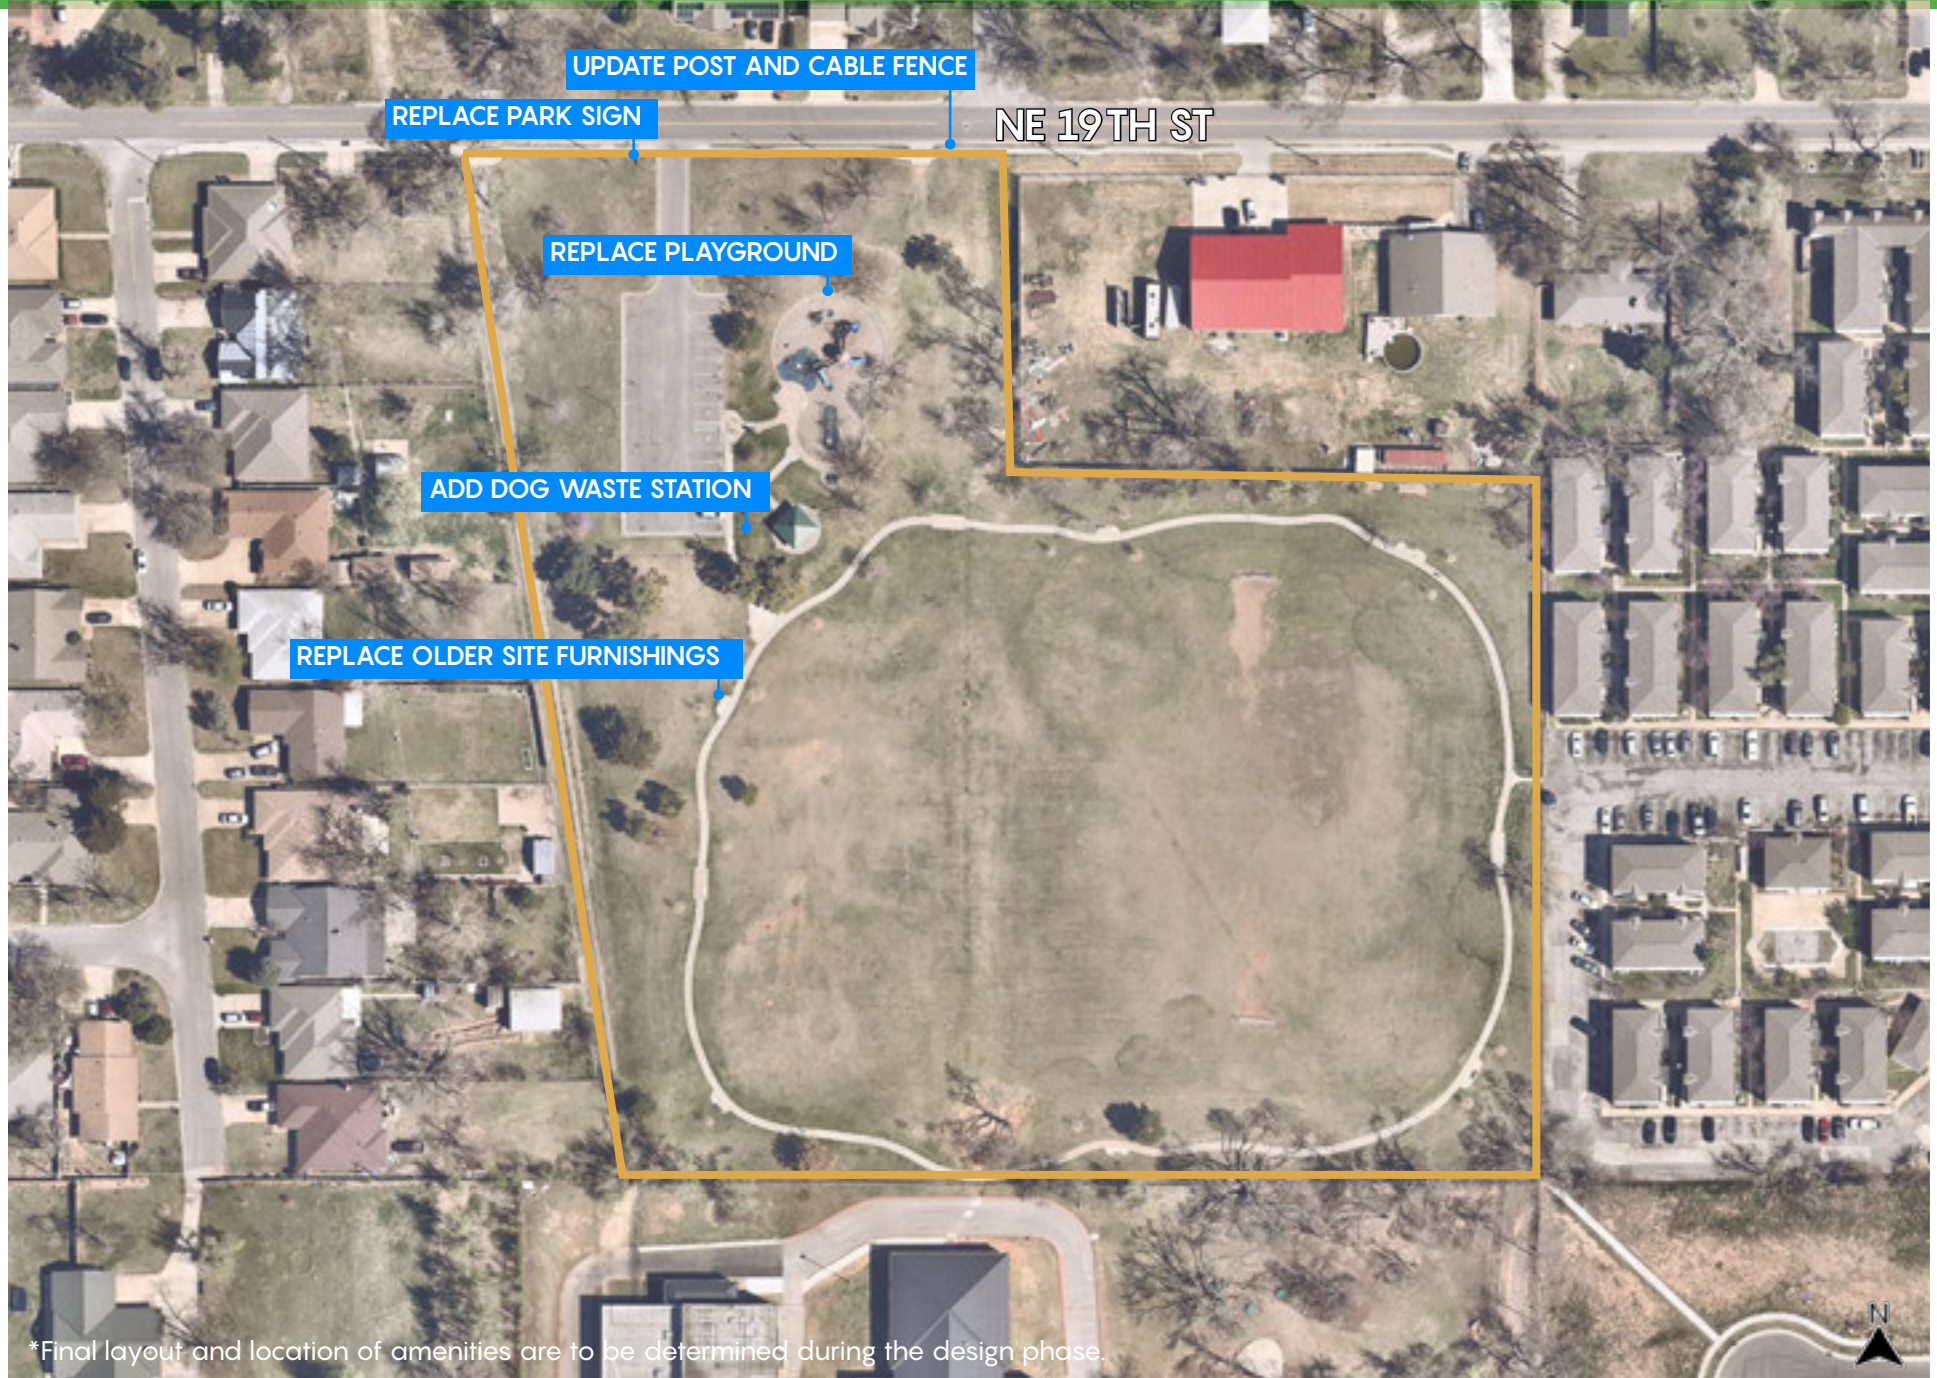
4.34 Harlow Park

Amenity	Qty.	Grade	Notes
BBQ Grill	2	C	Rusting.
Bench	10	F	Benches rusting and coating coming off. Wood benches are warped and starting to decay or missing seats.
Multi-Use Field	1	B	Turf in decent condition. Needs re-stripping on soccer portion. Goal posts in decent condition.
Parking Lot	1	C	Needs re-stripping and general repair. Minor cracking.
Picnic Table	3	F	Tables are rusting / deteriorating.
Playground	1	F	Old fading surface. Platforms rusting and show major wear. Surface have multiple patches and needs repair.
Post And Cable Fence	N/A	D	Cables are rusting, posts in decent condition.
Shade Structure	1	B	Decent condition, needs general clean up.
Sidewalks	N/A	B	Sidewalks are in decent condition, with minor cracking.
Signage (Park Entry)	1	D	Wood posts and panels deteriorating.
Swing Set	1	D	Rusting and coating coming off.
Tree Coverage	N/A	C	
Open Space	N/A	B

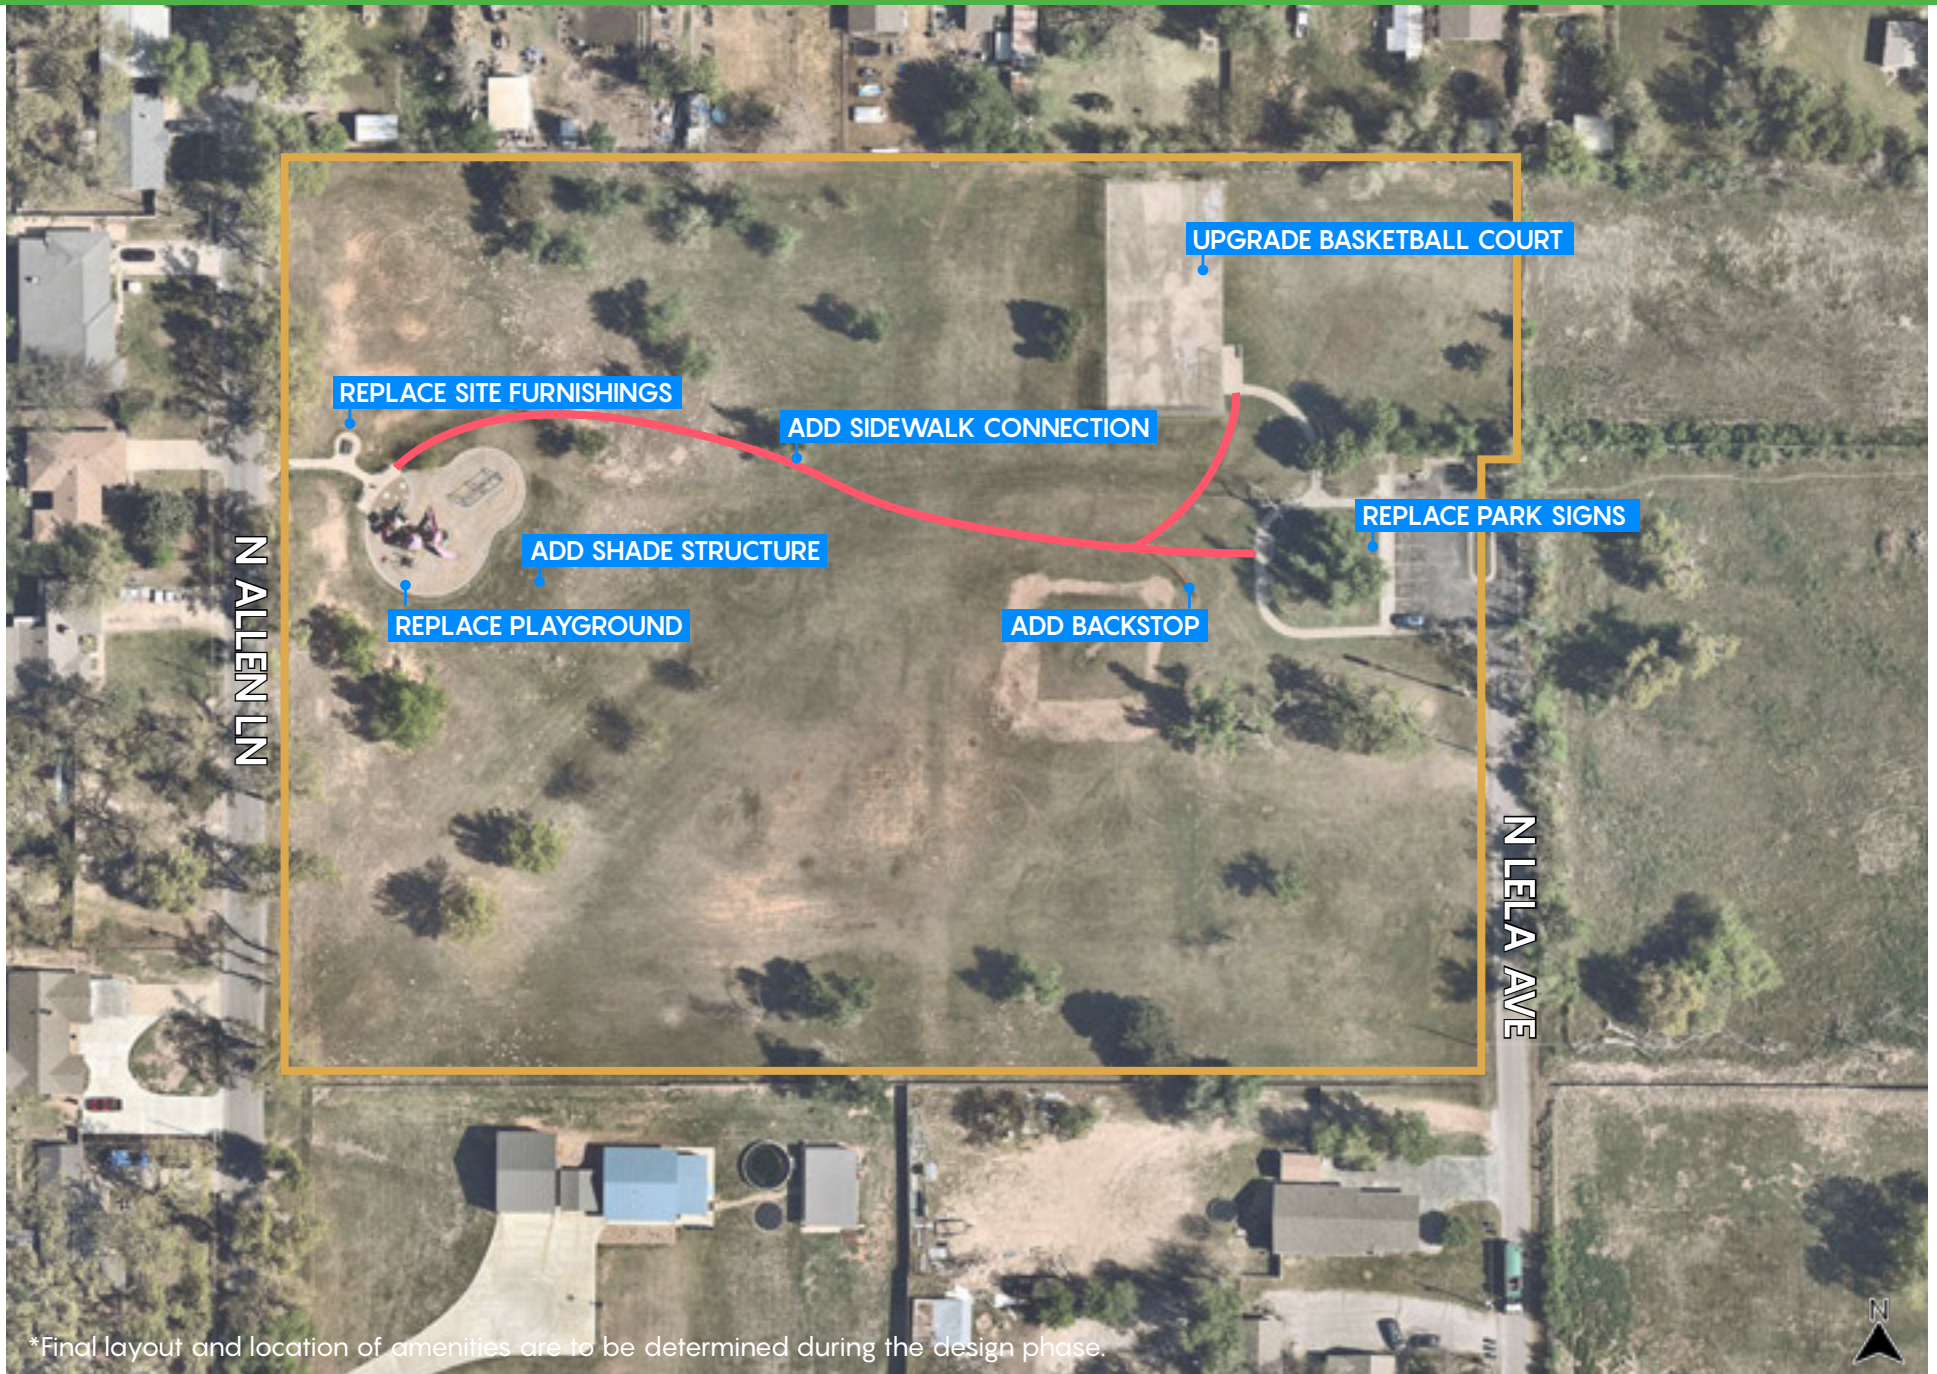
4.45 Lela Park

Amenity	Qty.	Grade	Notes
Basketball Court	1	D	Concrete pad is in decent condition with minor cracks. Fencing and goal posts show minor rusting. Striping is completely faded. Court is missing one goal.
Bench	5	F	Benches are rusting and coating is wearing off. Wood benches are aging.
Multi-Use Field	1	D	Turf is in decent condition. Backstop is missing. Temporary backstop/pitchers mound has been created.
Parking Lot	1	B	Overall decent condition. Minor cracking in surface.
Picnic Table	1	F	Table has major rusting and coating is wearing off.
Playground	1	F	Equipment is aging and sun-faded with some rusting on the platforms. One slide has a hole. Playground surface is in fair condition.
Post And Cable Fence	N/A	F	Missing cables and has major rusting.
Sidewalks	N/A	C	No connections from east to west sides of park. Minor cracking in some areas.
Signage (Park Entry)	2	F	Wood deterioration and cracking on posts. Sign missing near parking lot.

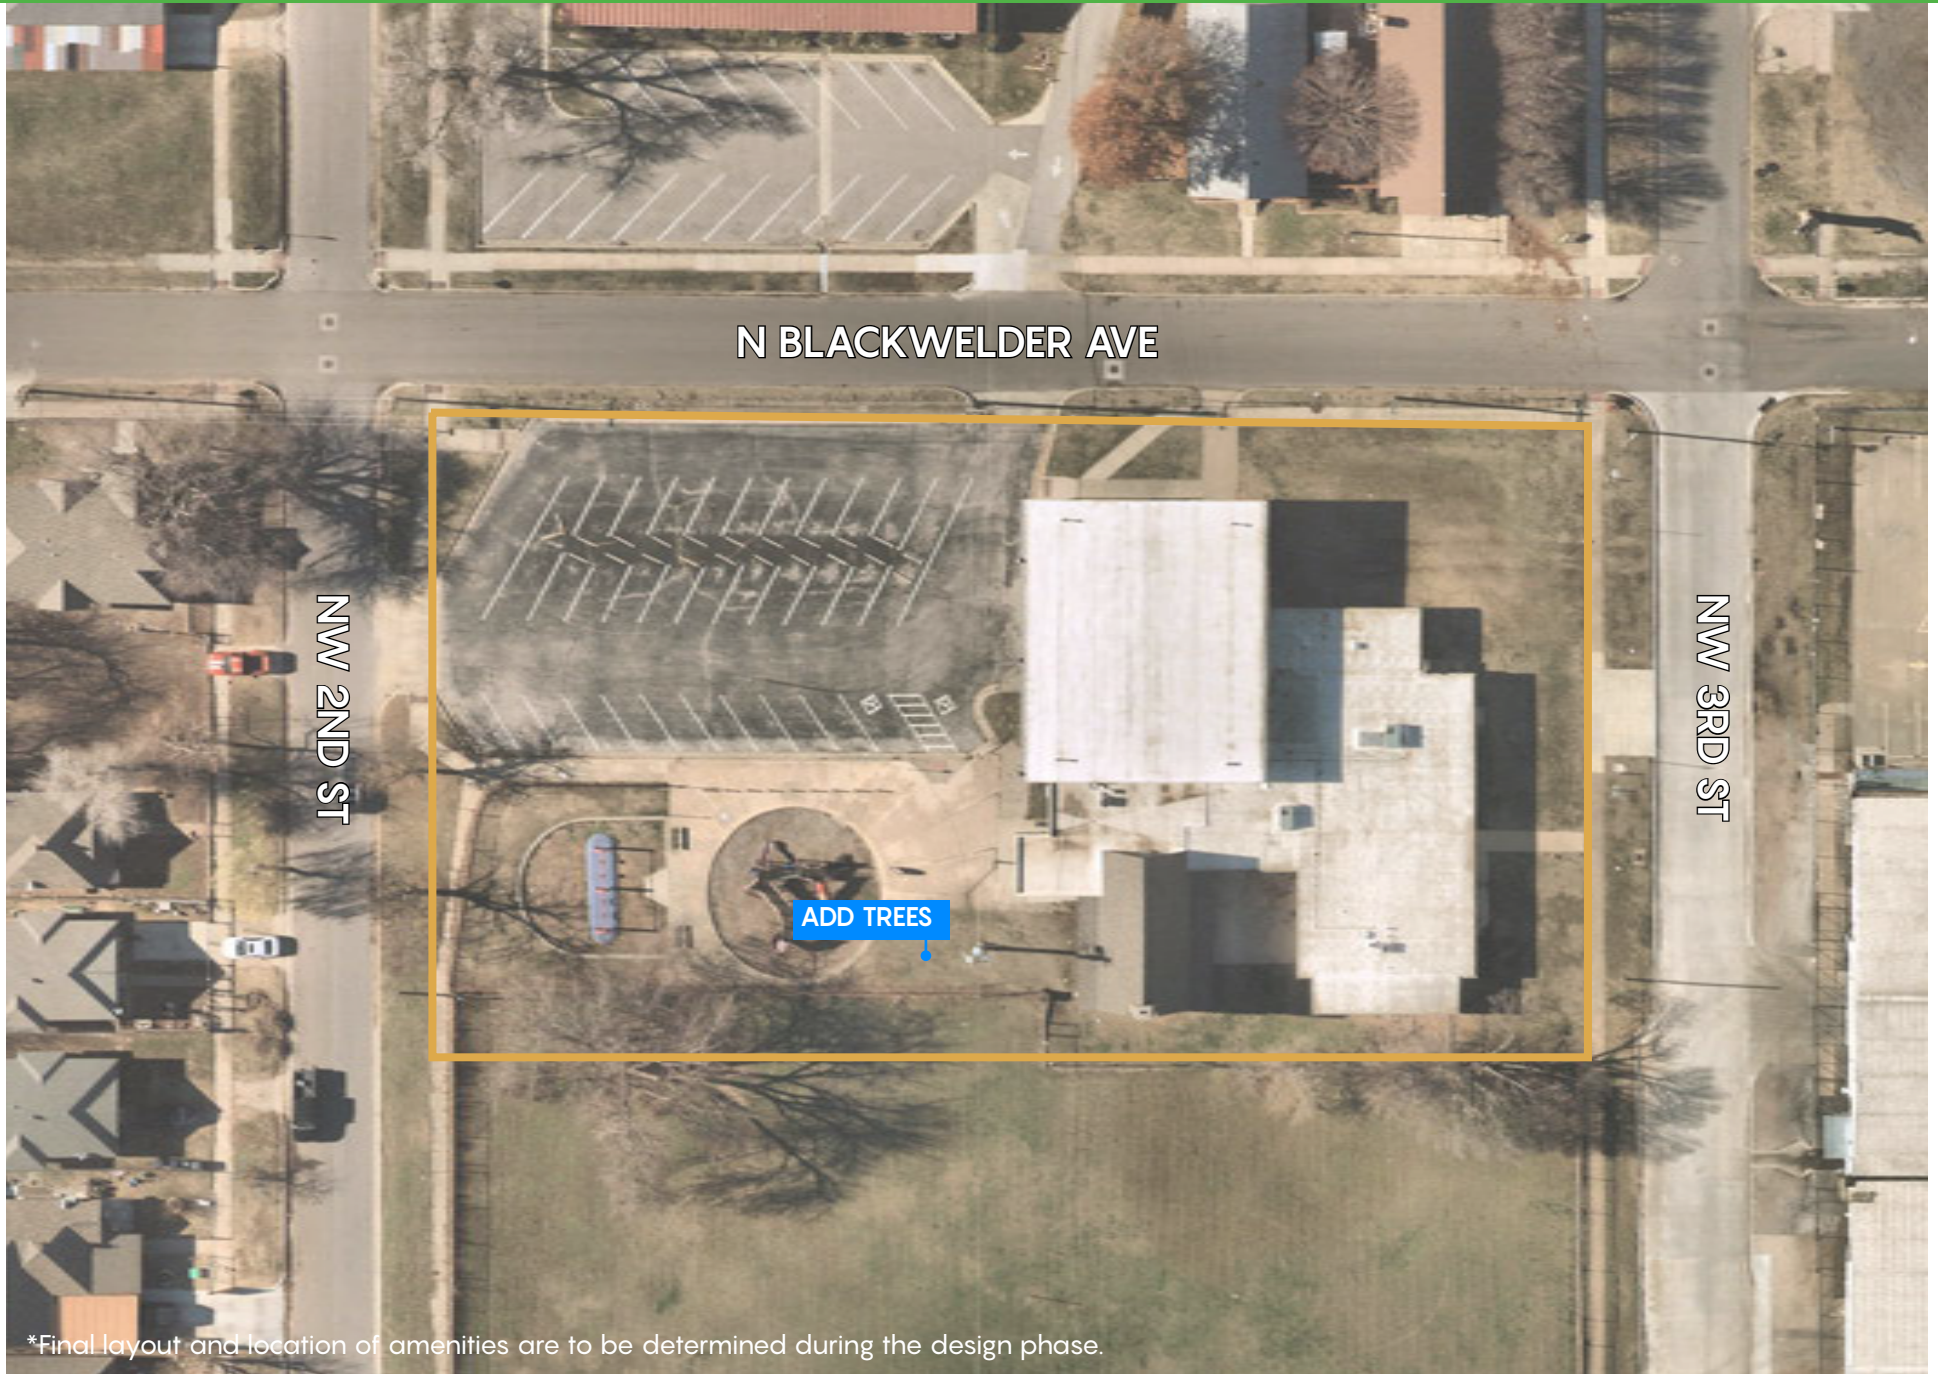
4.76 Pilot Center

Amenity	Qty.	Grade	Notes
Bench	2	F	Benches are rusting and coating is wearing off.
Bollards	9	C	Paint is wearing off.
Parking Lot	1	D	Some wheel stops are deteriorating/broken.
Playground	1	F	Equipment is sun-faded with rusted platforms.
Sidewalk	N/A	D	Sidewalk/concrete near the building and near 2nd street has cracking throughout.
Signage (Park Entry)	1	F	Signage is deteriorating and not upright.
Swing Set	1	C	In good decent condition with chains rusting.
Tree Coverage	N/A	C	
Open Space	N/A	C
